repair sequence

Hanalei Pier Repair Project

Rotary Club of Hanalei Bay
Hanalei, Kauai, Hawaii

Mar 16, 2011

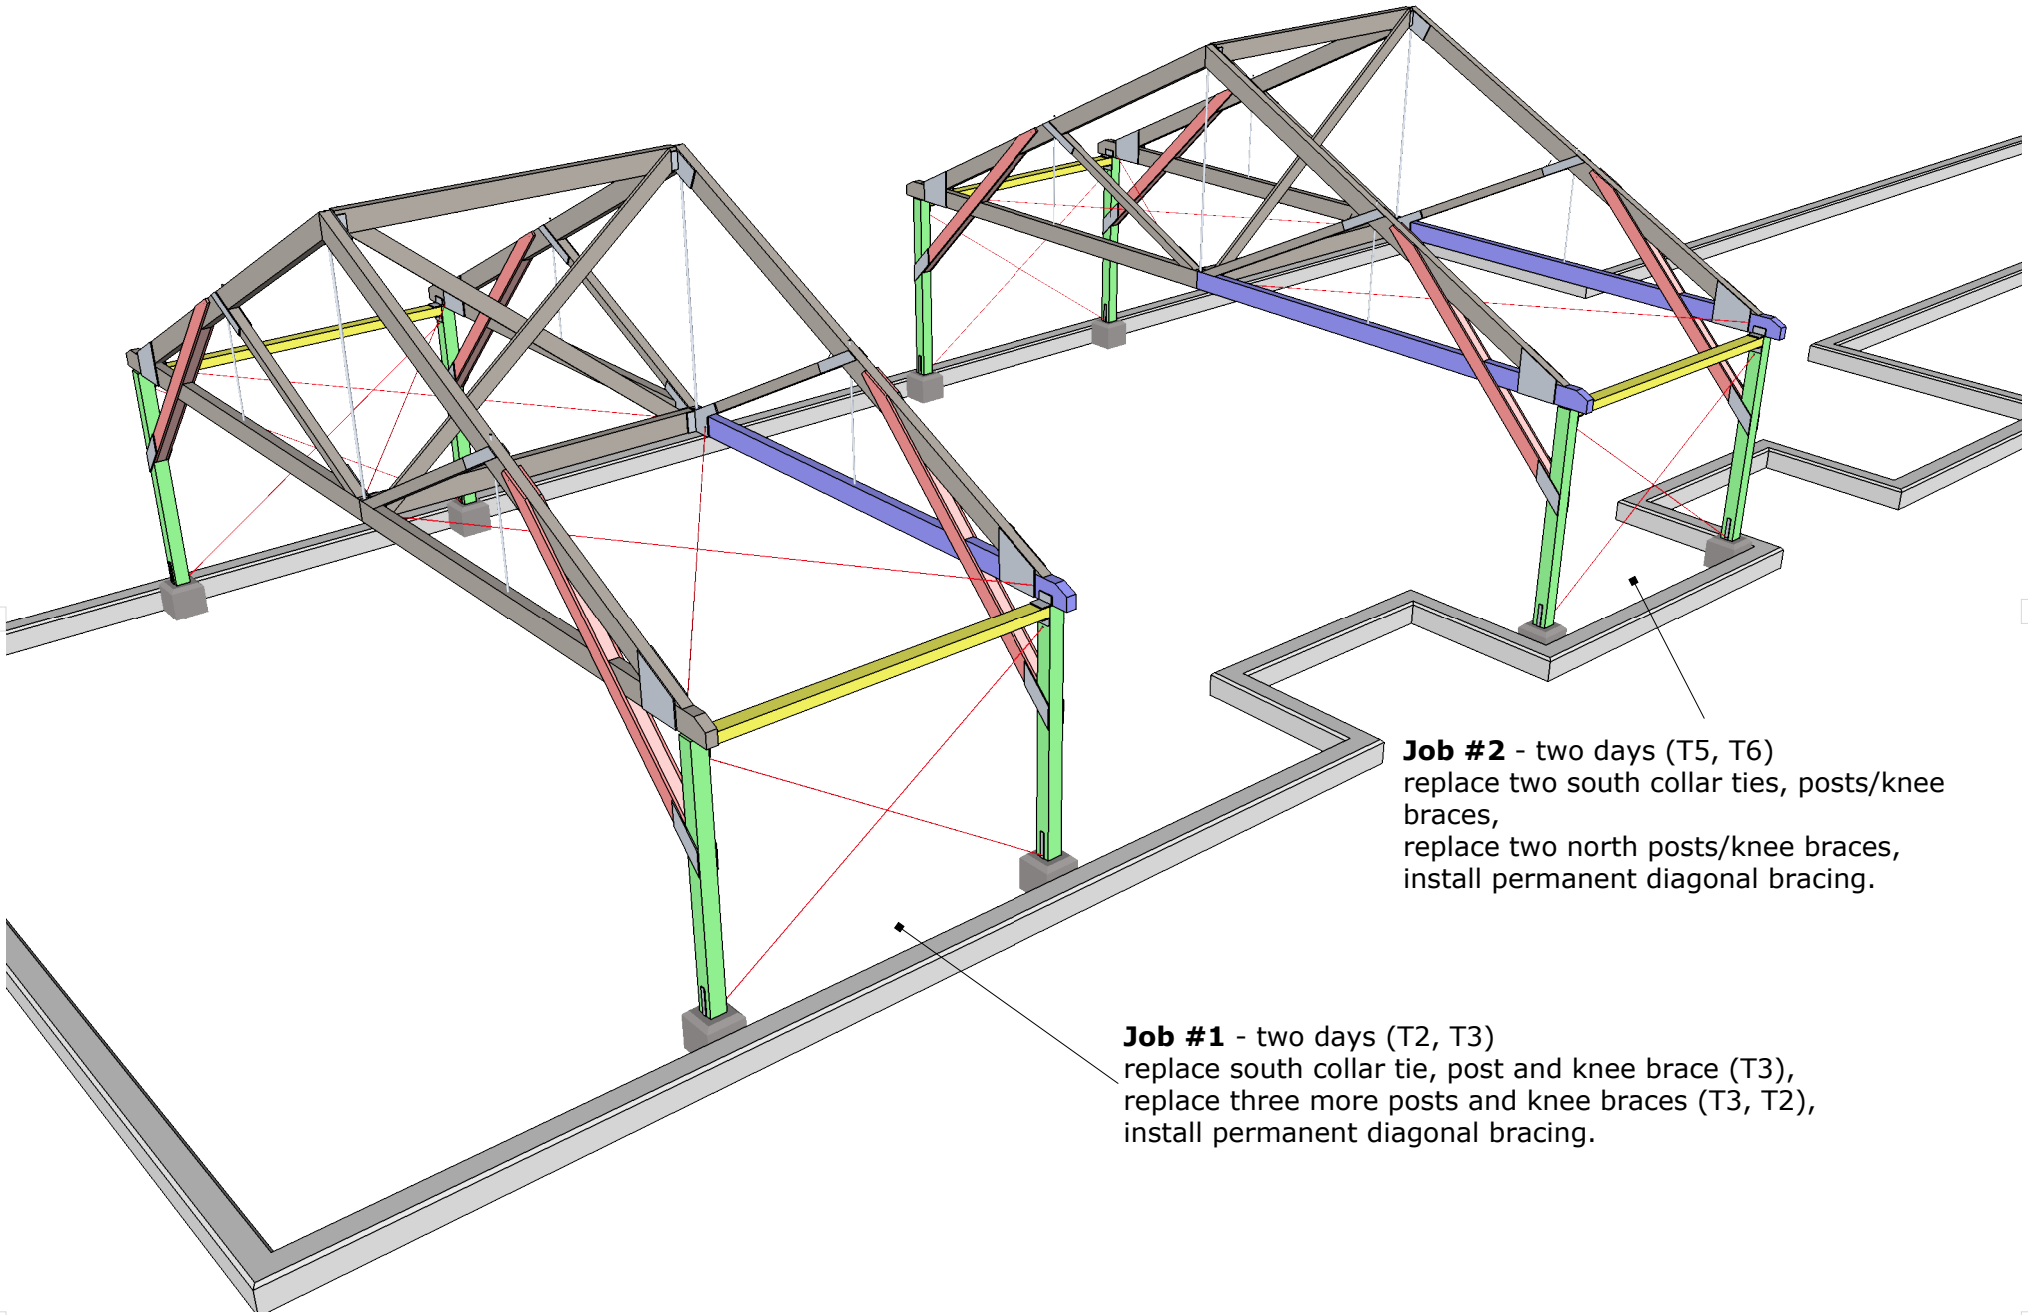
NOTE: X-Beams left untouched

Job #2 - two days (T5, T6)
replace two south collar ties, posts/knee
braces,
replace two north posts/knee braces,
install permanent diagonal bracing.

Job #1 - two days (T2, T3)
replace south collar tie, post and knee brace (T3),
replace three more posts and knee braces (T3, T2),
install permanent diagonal bracing.

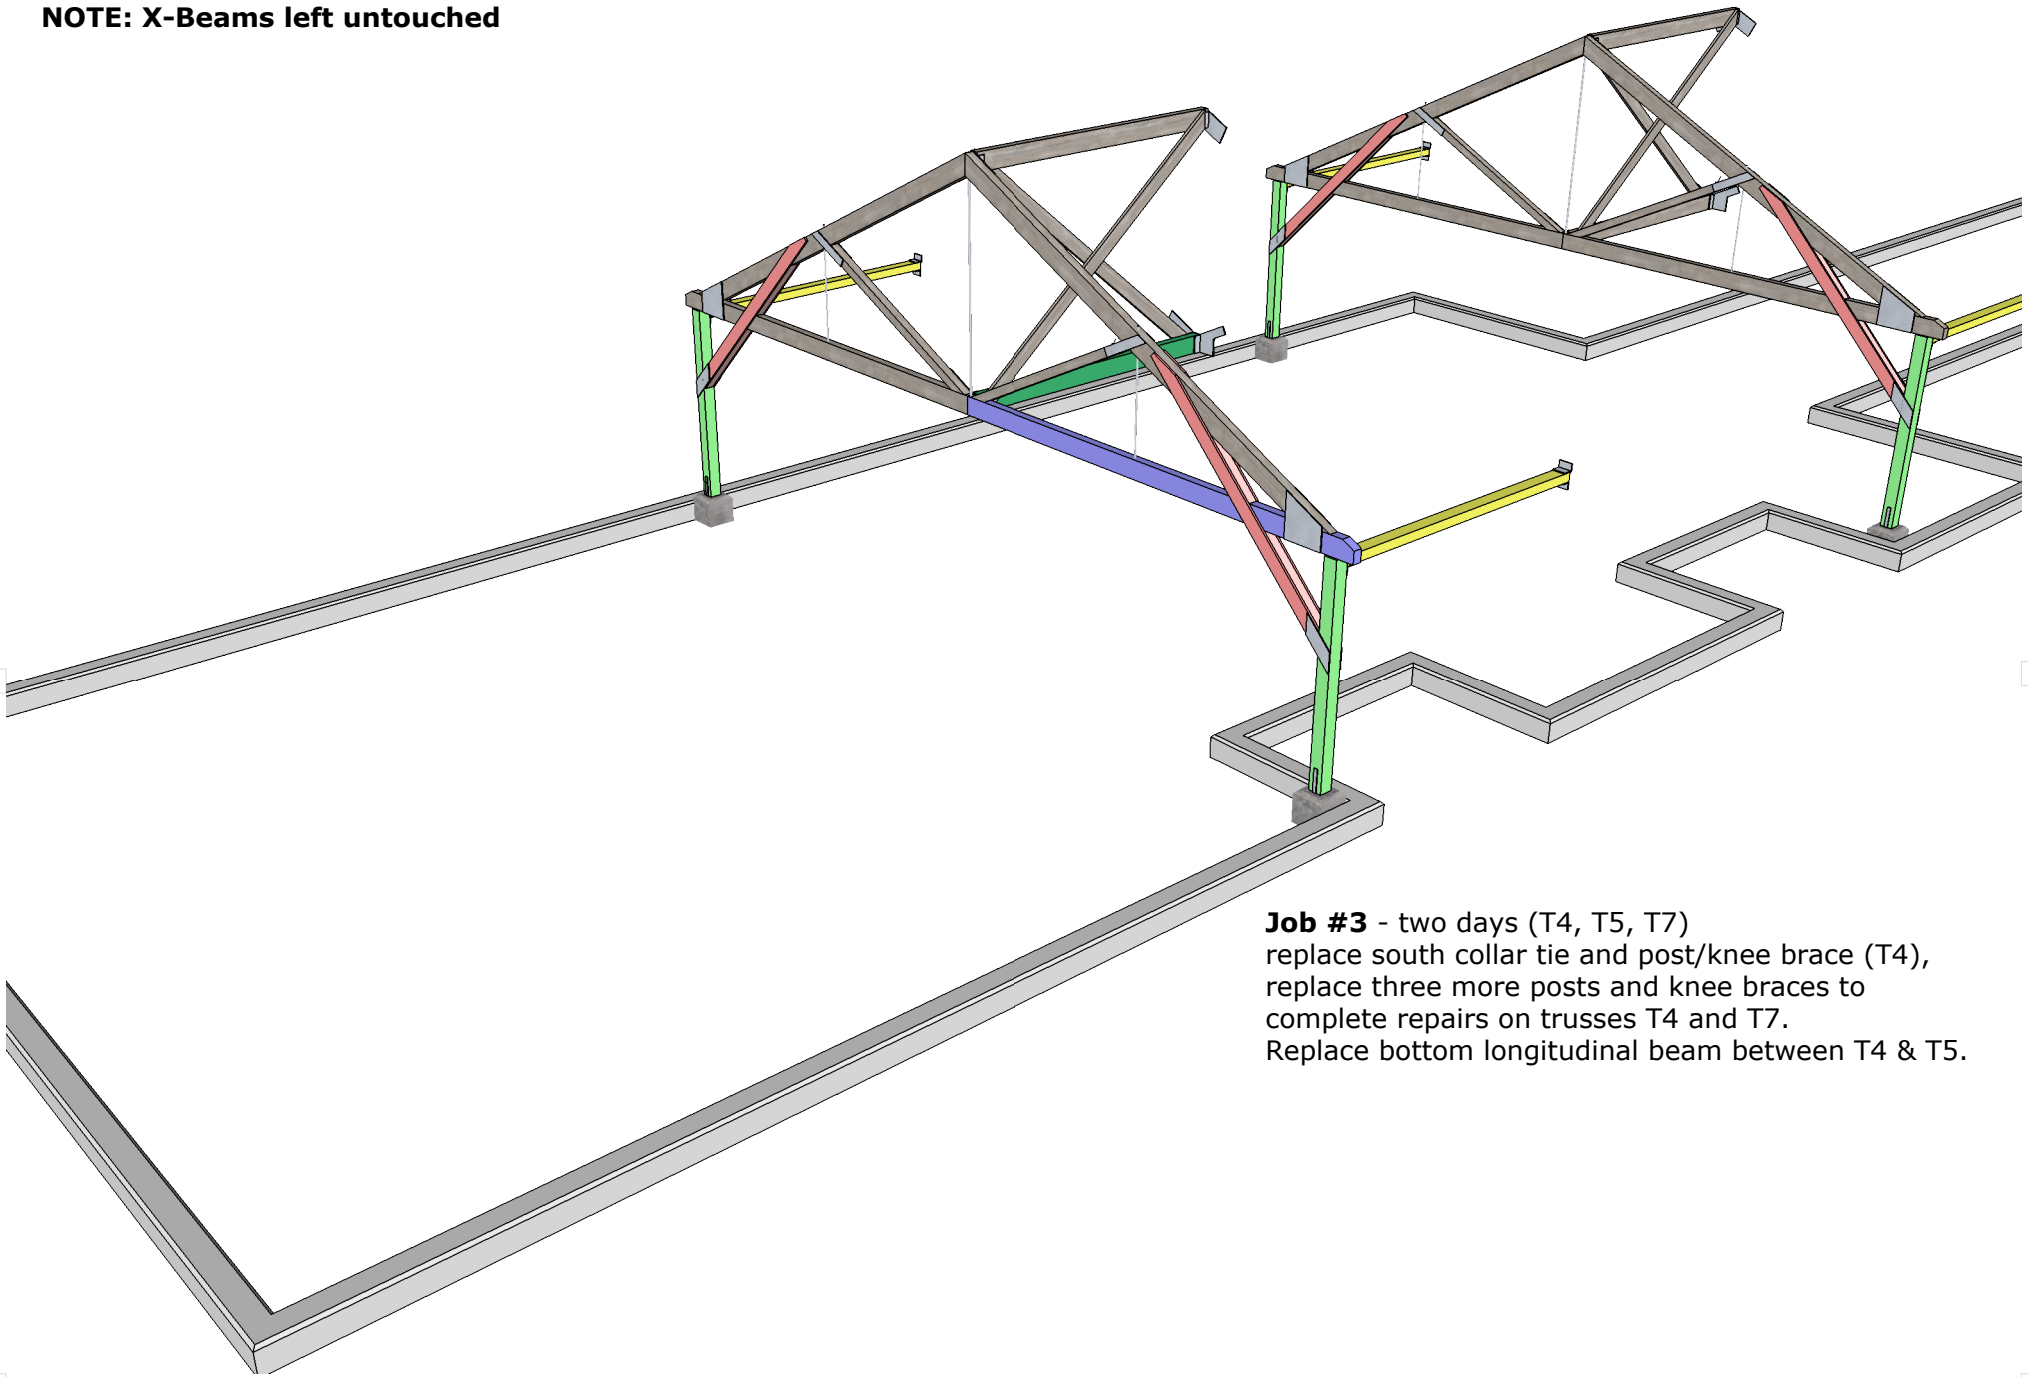
job 3 - T4 & T7

NOTE: X-Beams left untouched

Job #3 - two days (T4, T5, T7)
replace south collar tie and post/knee brace (T4),
replace three more posts and knee braces to
complete repairs on trusses T4 and T7.
Replace bottom longitudinal beam between T4 & T5.

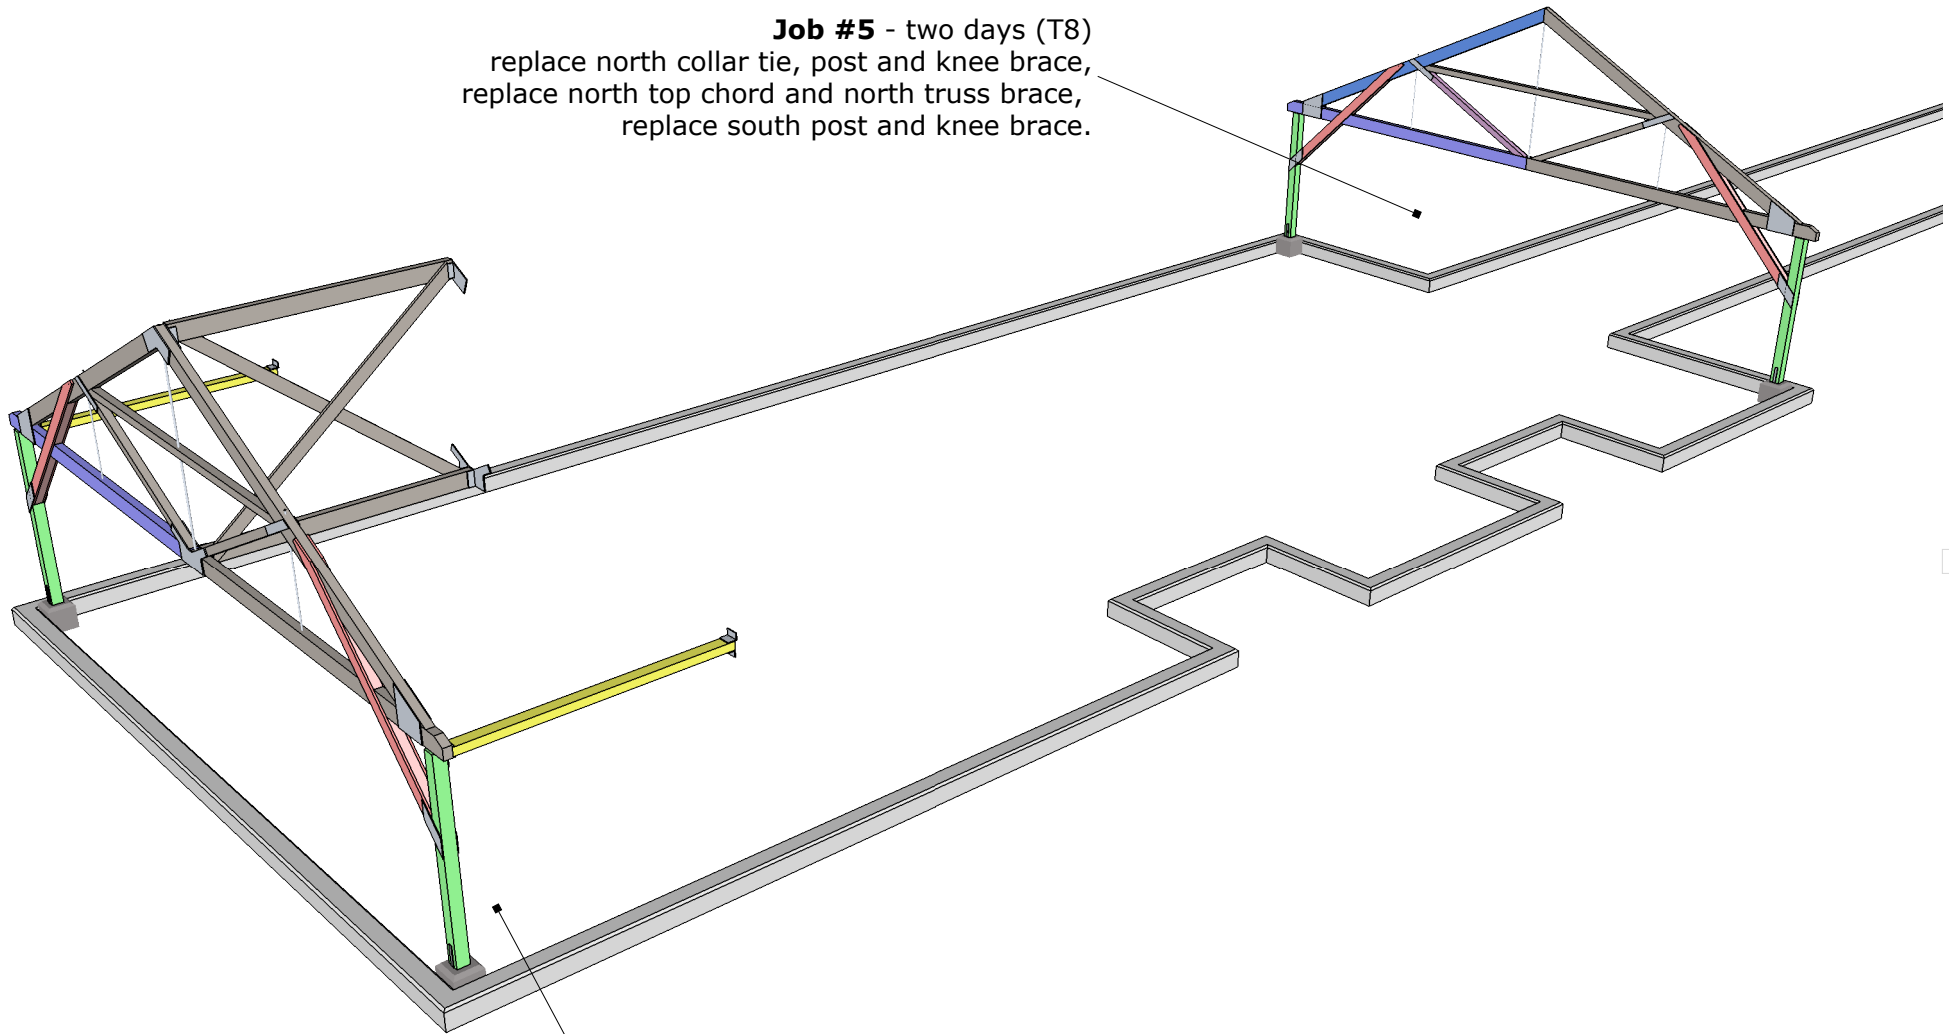
jobs 4 & 5

NOTE: X-Beams left untouched

Job #5 - two days (T8)
replace north collar tie, post and knee brace,
replace north top chord and north truss brace,
replace south post and knee brace.

Job #4 - one day (T1)
replace north collar tie, post and knee brace,
replace south post and knee brace.
